Hahnemann Monument Restoration Project

A Public/Private Partnership

Sandra M. Chase, MD, DHT, Chairman,
American Institute of Homeopathy Hahnemann Monument Preservation Committee
April, 2006

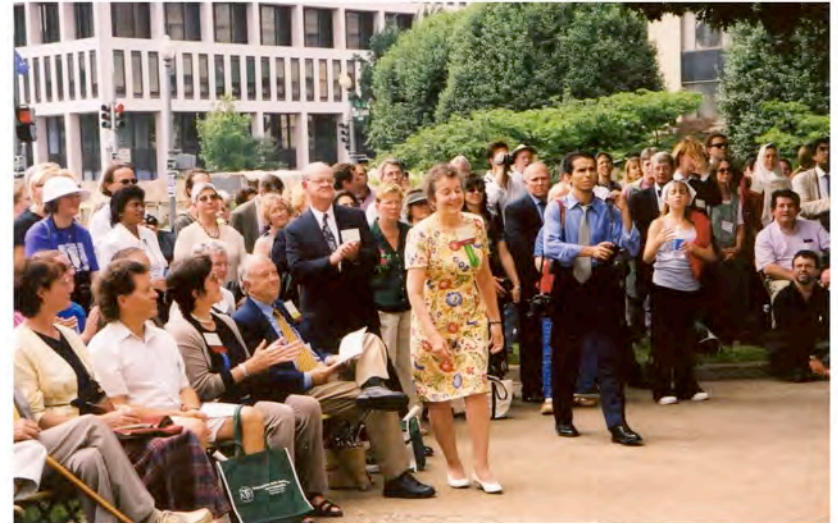
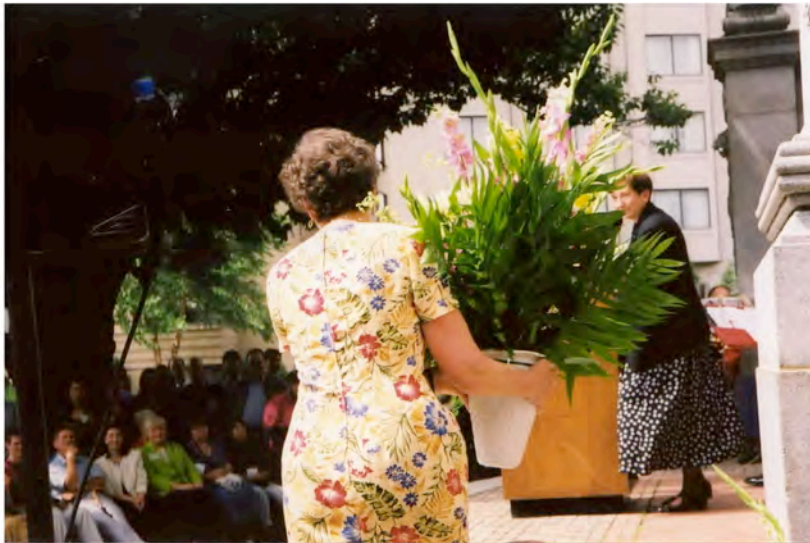
[Again, see the defects visible in the mosaic arch.]

It is a little hard to see in this picture, but at the very bottom margin of the mosaic arch above Hahnemann's head, one can see that there are missing pieces in the mosaic pattern, which, by the way, represents a stylized depiction of Cinchona's leaves and flowers.

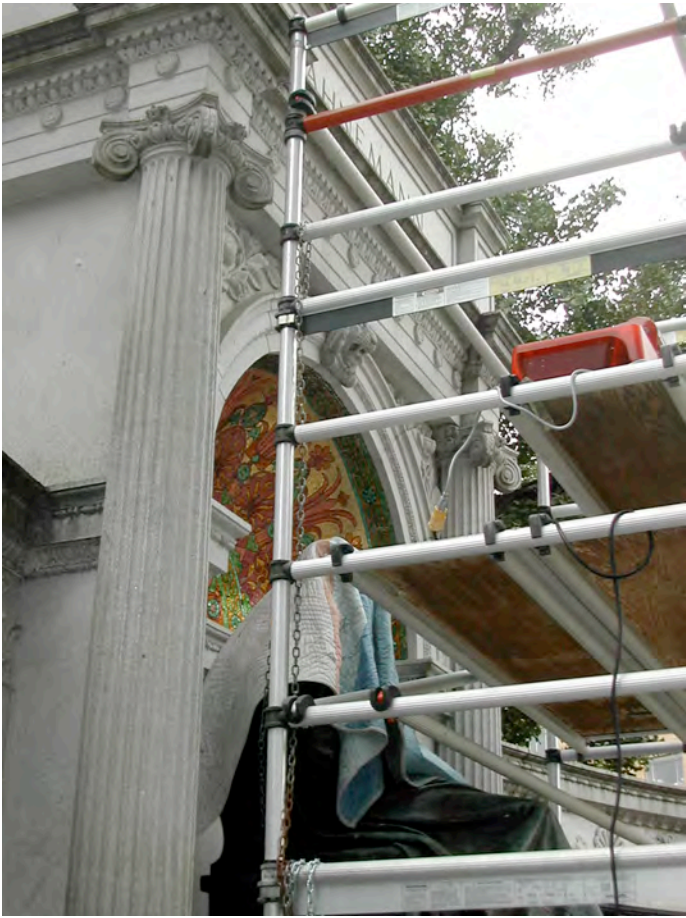
The monument with its Greek exedra form and its flanking benches is an attraction to the homeless.

The scaffolding had to be chained to the monument to prevent its being stolen.

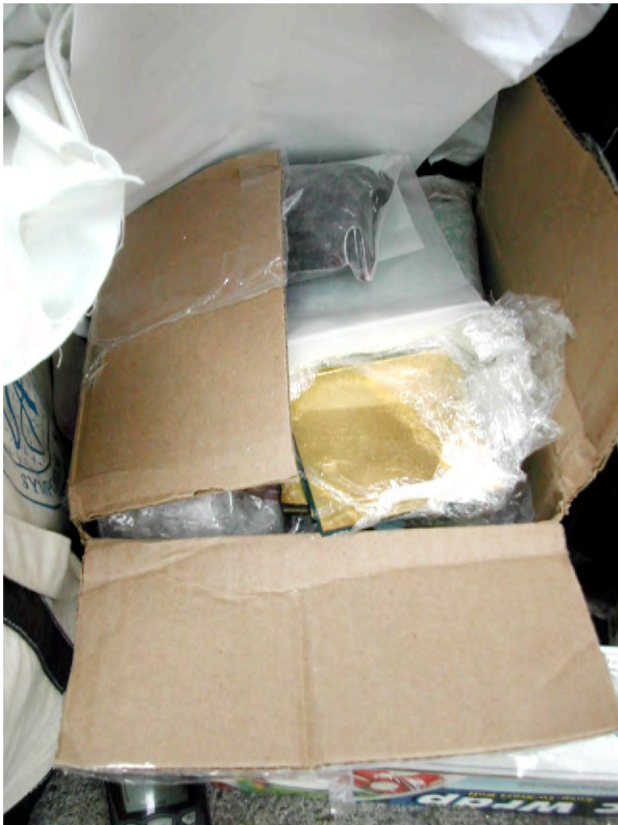
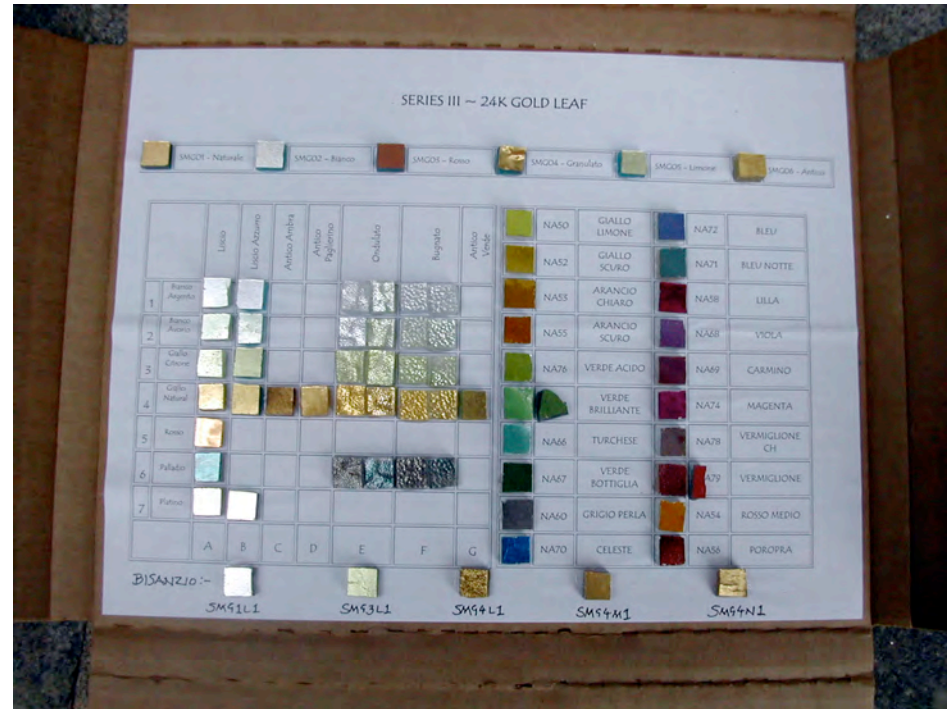
The original glass used in the mosaic arch is a “sandwich” of deep blue colored glass overlaid with gold leaf and then another layer of colored glass. There are basically three colors that were used, gold, green and pink.

In this photograph, one can see a piece of the “old” green and of the “old” pink next to the closest match.

The repair glass has a silver colored metal between the glass layers. On the face of it, the matches were fairly close.

Interestingly, the mosaic in the arch over C.F. Samuel Hahnemann’s head is not made of ceramic tile at all, but of pieces of glass, termed tesserae. Ms. Jacob had to search to find suitable repair materials, failing which, the glass would have had to be custom made, at a greater cost, of course. She obtained the glass that she used for the restoration from Ori Colorati of Italy via a company in San Diego.

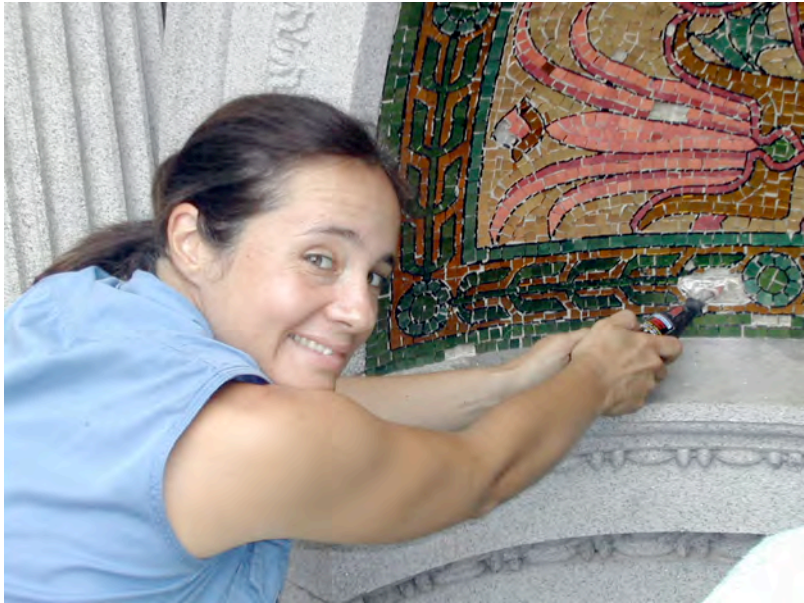
Here Art Preservation Technician Kimberly Carter is using a battery powered, hand-held tool to remove the old grout from an area in which the glass pieces will have to be cut into appropriately sized tesserae and affixed to the mosaic.

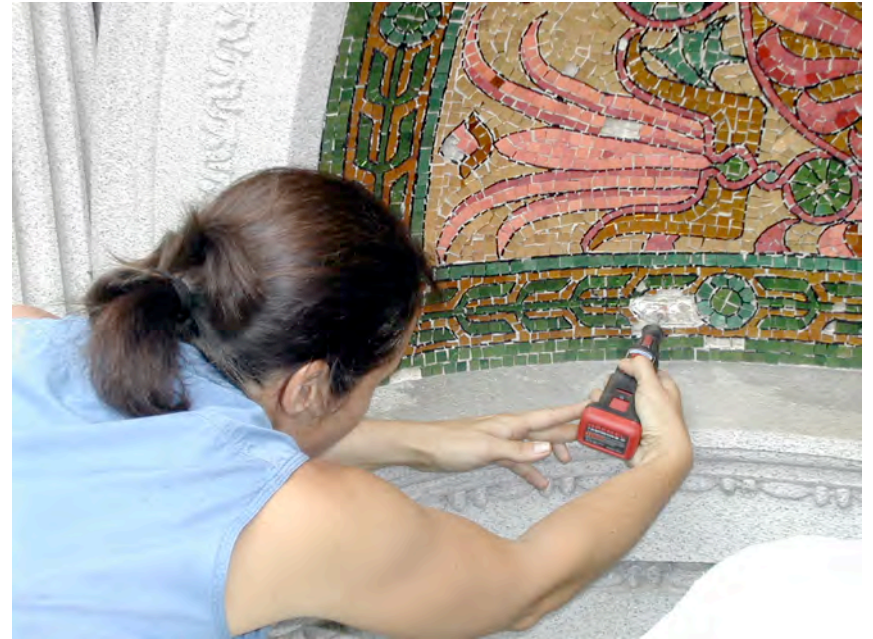
Senior Conservator Judy Jacob had a glass cutting machine up on the scaffolding in front of the monument, powered by a portable generator sitting on the ground below. The glass cutting machine was used to cut the square stock glass into smaller pieces from which the tesserae needed for repair were chiseled using dental tools.

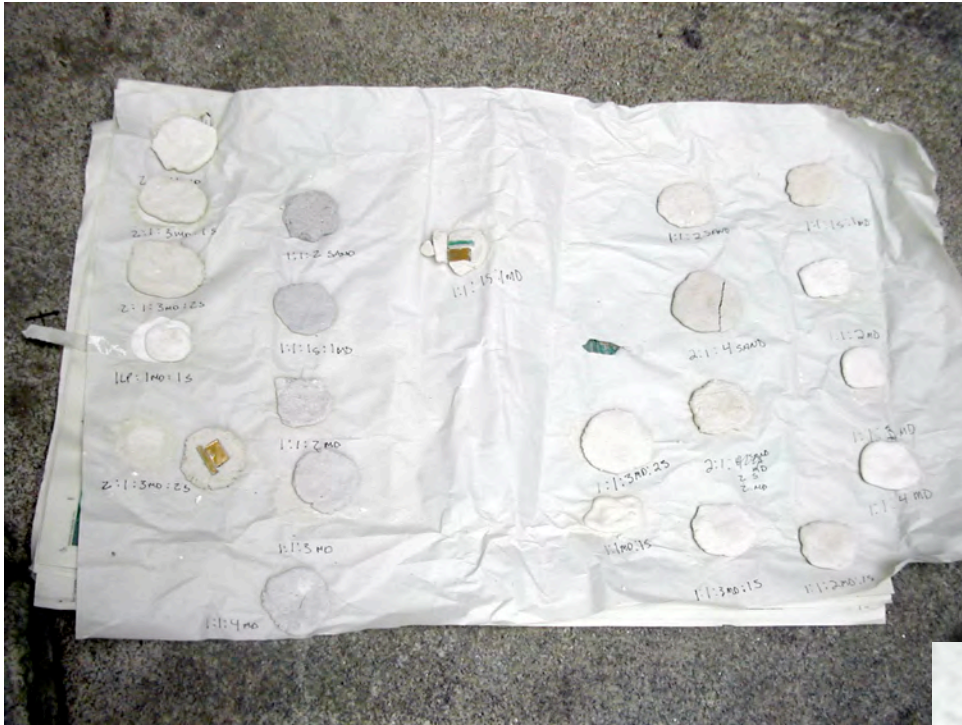
Here we see a palette of various grout mixtures prepared by Ms. Jacob in an attempt to match the old grout or mortar in the mosaic arch.

The selected mixture of mortar for the setting of the replacement glass pieces comprised the following:
2 parts hydraulic lime, 1 part lime putty, 4 parts marble dust,
and 2 parts fine sand.

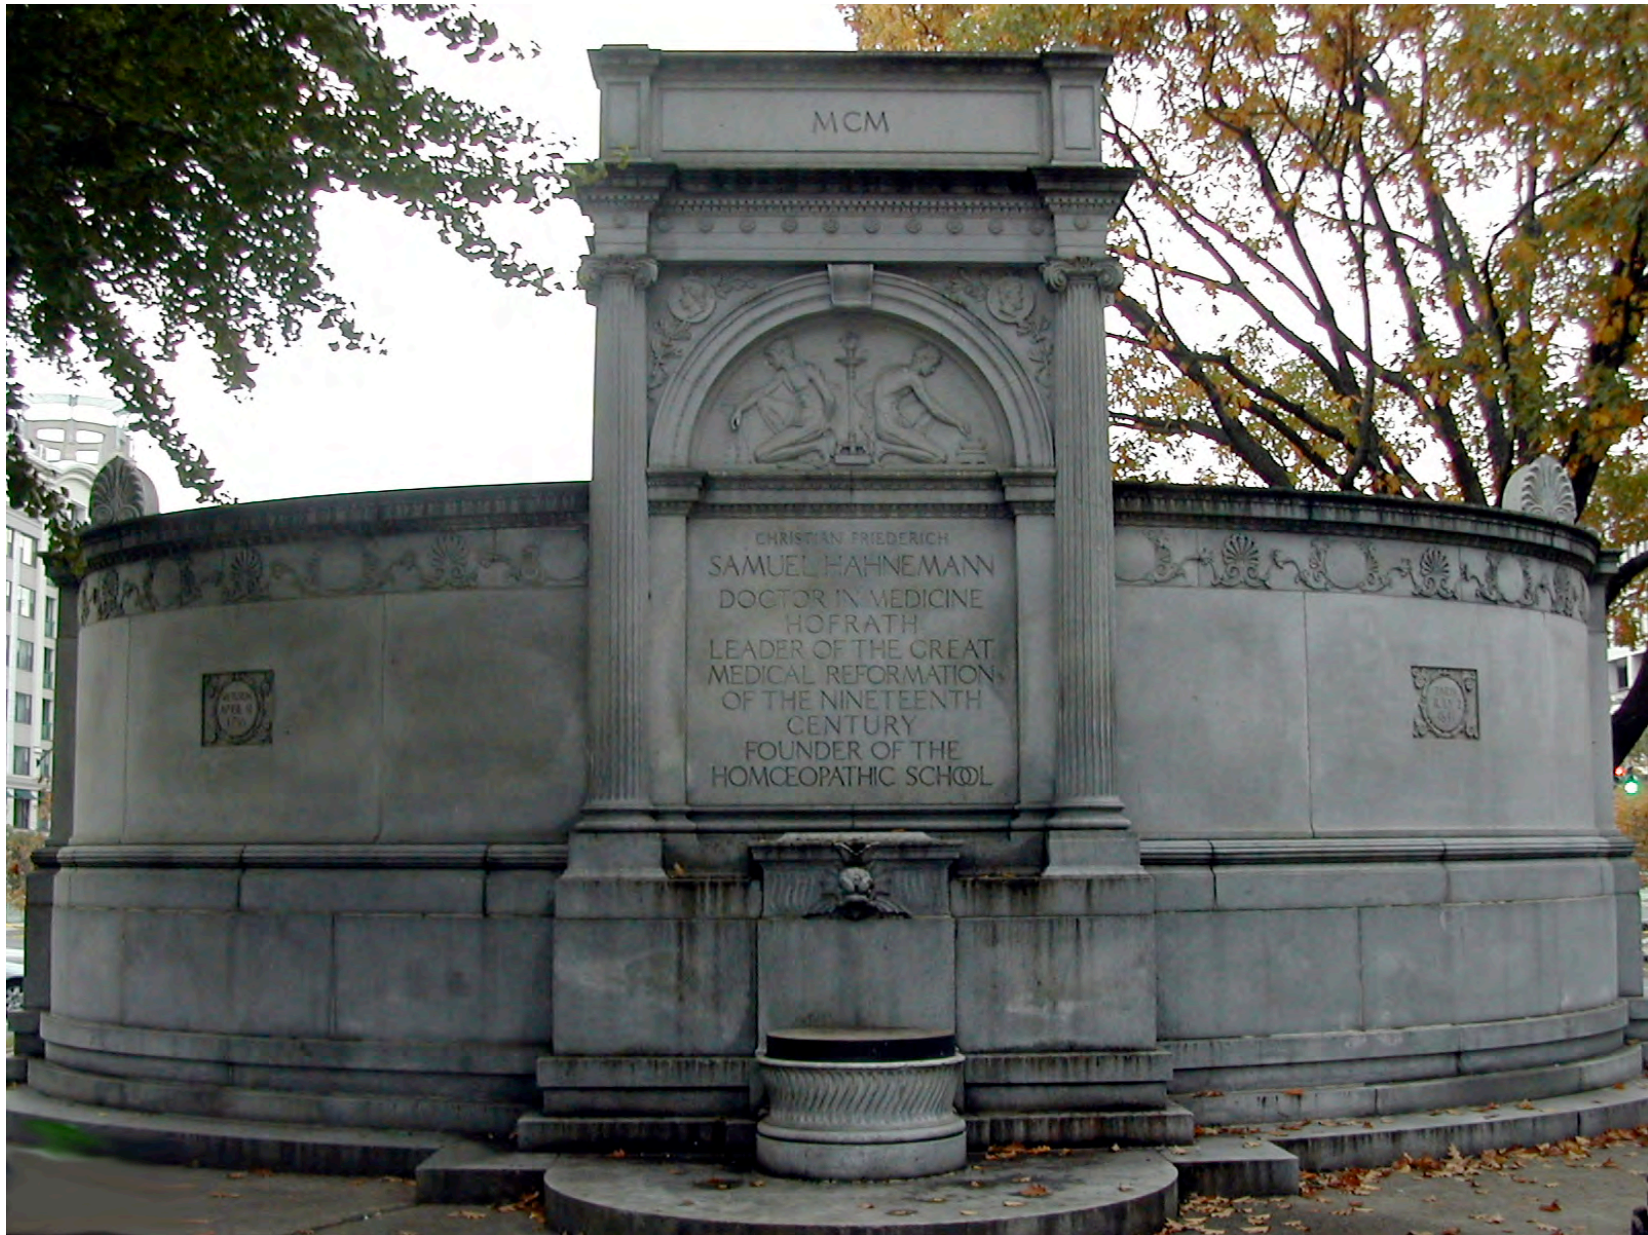
Environmentally compatible cleaning methods that would also not prove damaging to the memorial itself mean that the surface of the granite of even the cleaned monument will not be uniform in appearance.

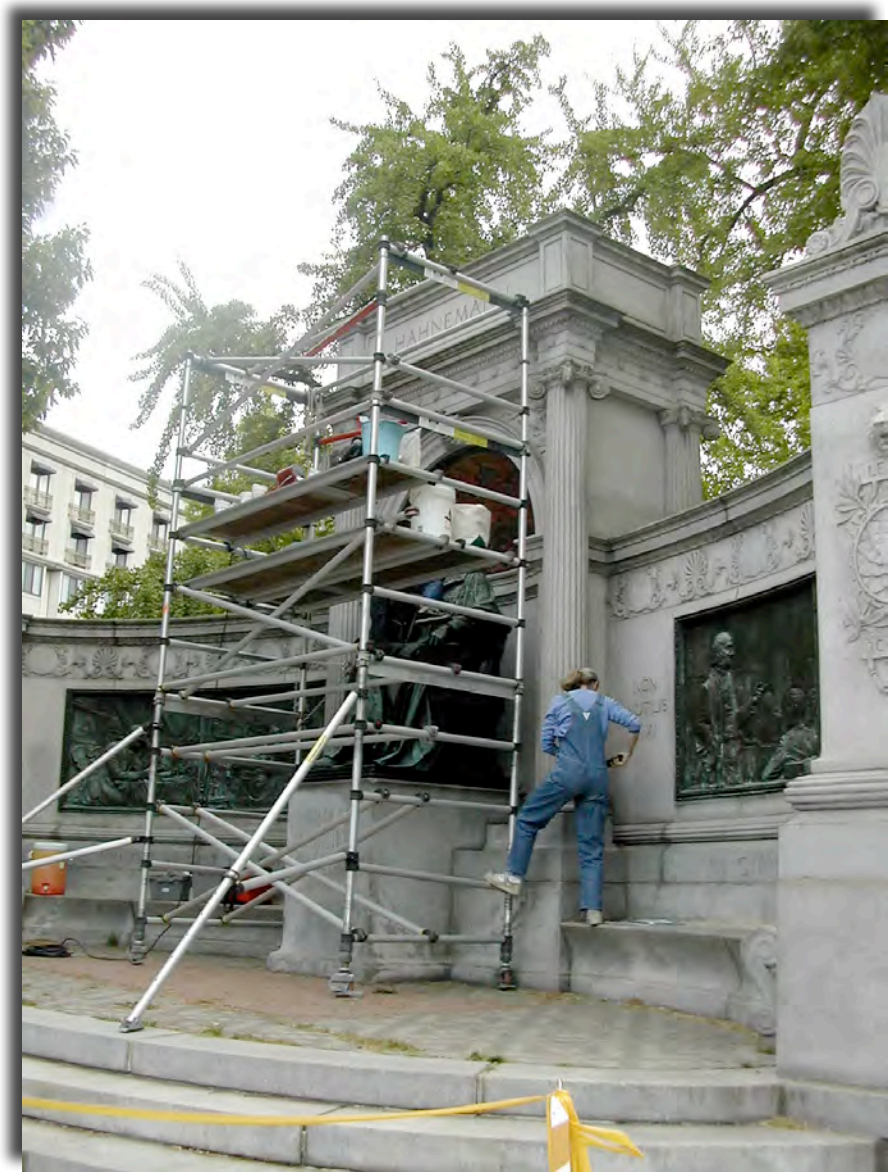
We arrived to find Ms. Jacob and her assistant working on the mosaic up on the scaffold erected surrounding the statue of Hahnemann.

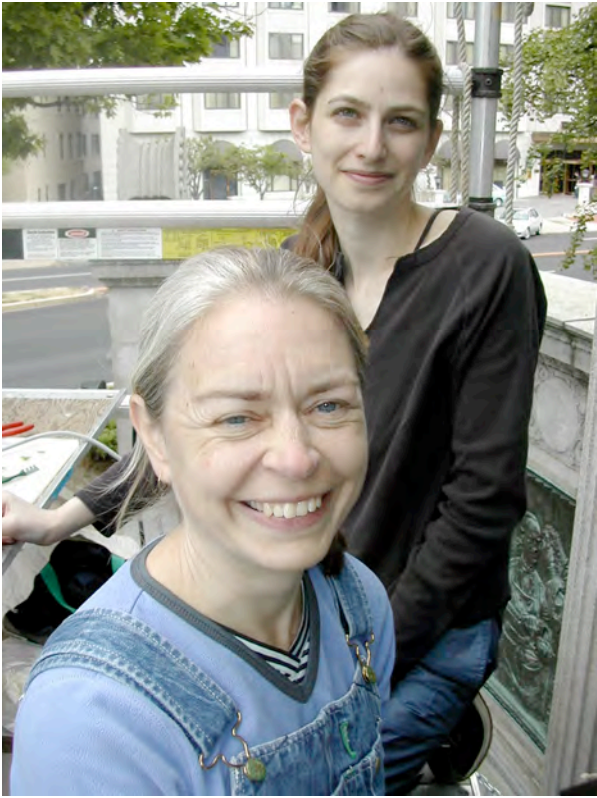
This time Ms. Jacob's contracted assistant was Object Conservator Lara Kaplan, pictured here with Senior Conservator Judy Jacob on the scaffolding.

In order to reach the mosaic arch to effect repairs, Ms. Kaplan had to rest on Hahnemann's shoulder. I told her and Ms. Jacob, in some homeopathic circles, that might be considered sacrilegious.

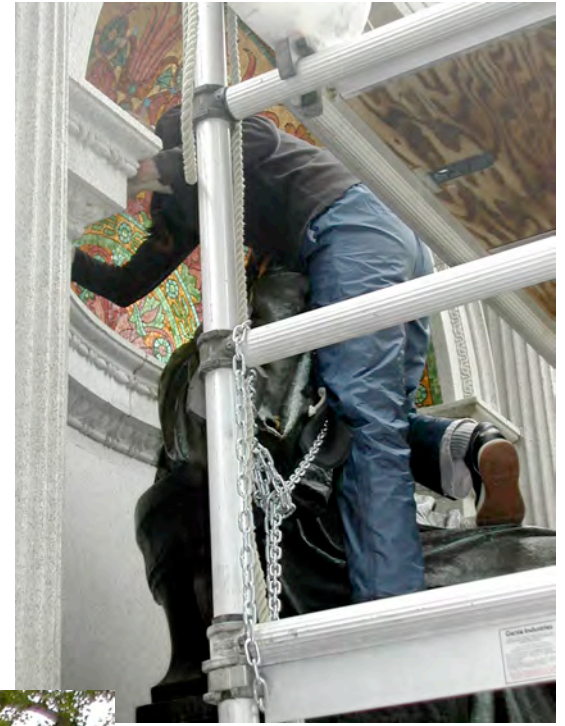
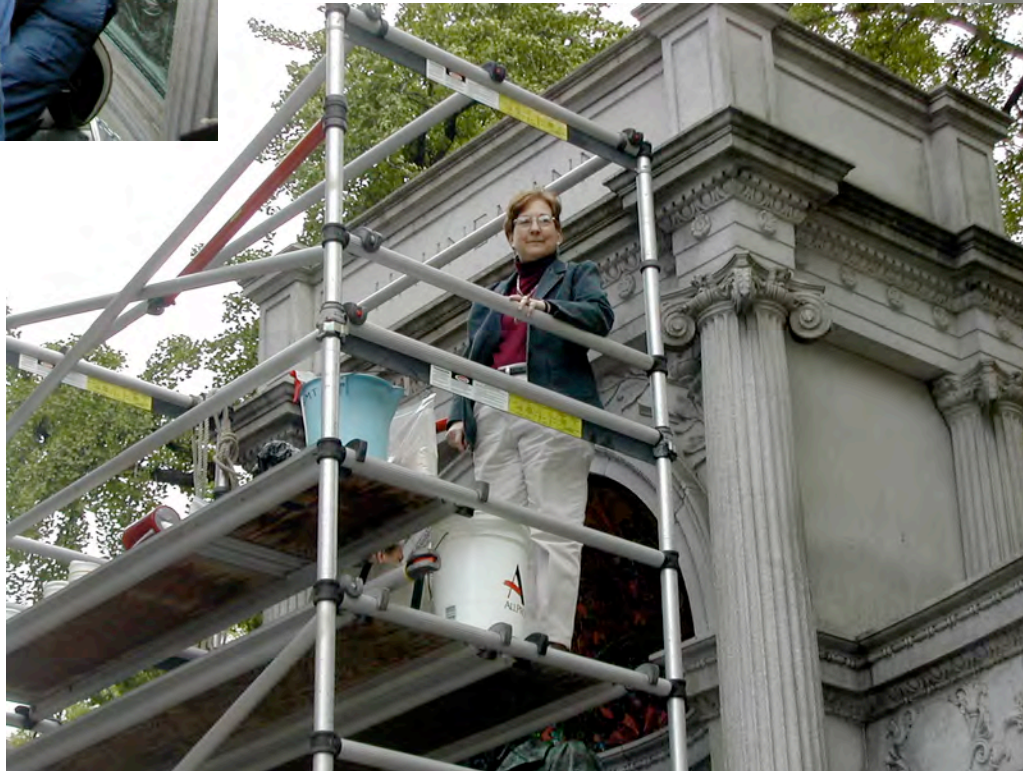
Joining Ms. Jacobs and Ms. Kaplan on the scaffolding allowed me to take close-ups of the ongoing mosaic repair.

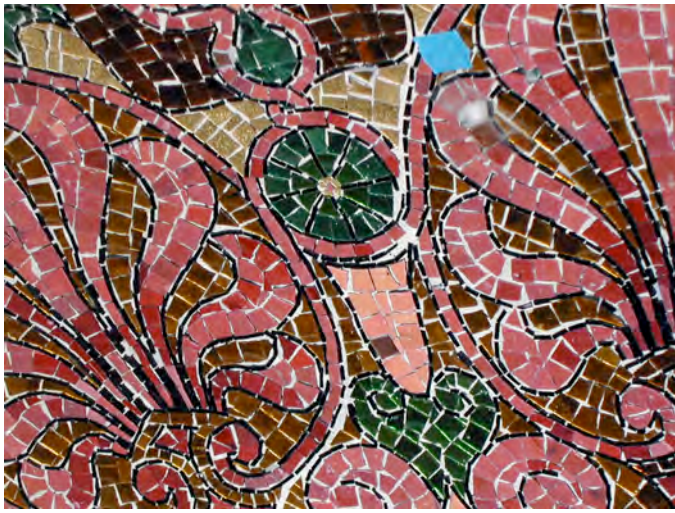
This close up of the mosaic, taken from the scaffolding up on which I had climbed, shows the blue tape that marks an area that needs repair. The area covered with scotch tape has been repaired. The tape is to retard the drying of the grout.

The repair of the mosaic arch is meticulous and must be done by hand.

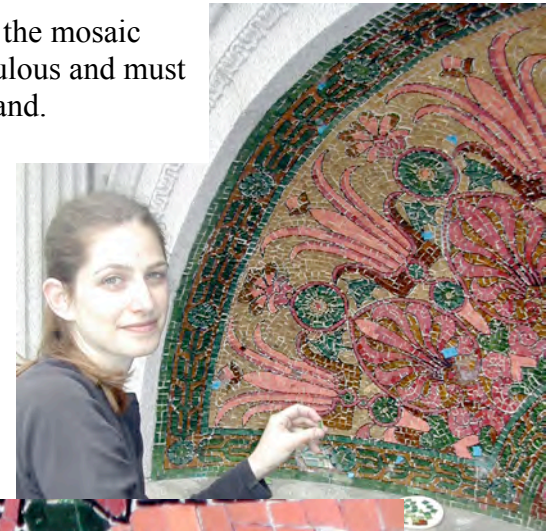
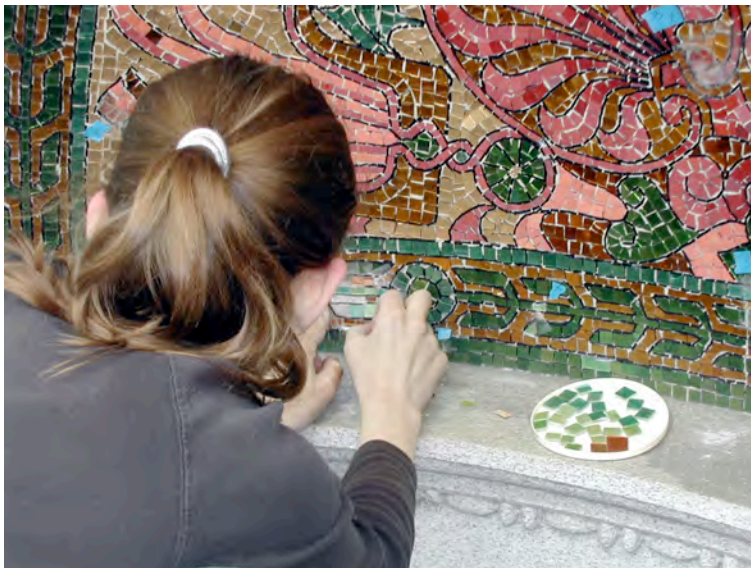
Here, we see Object Conservator Lara Kaplan inserting pieces of colored glass or tesserae cut to fit the area needing mending. To her right are small cut pieces of the especially ordered colored glass to be used in the repair.

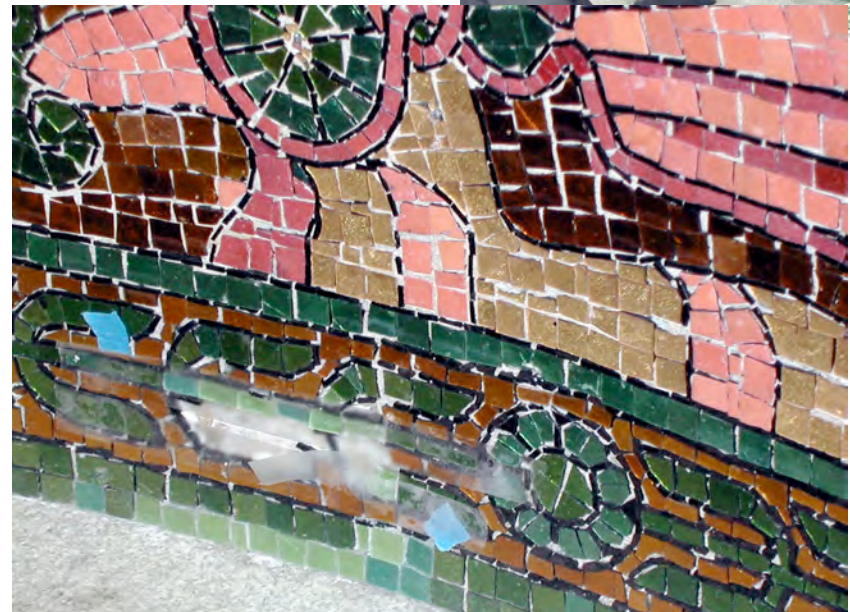
Here is another view of the mosaic arch. Again, the blue tape marks areas to be repaired and the scotch tape covers a newly repaired area. One can also see areas that have already been repaired in which, up close, the colored glass is somewhat different than the original. Viewing the monument from the ground, however, the appearance is fine.

In some areas, the mosaic pieces are crumbling, but not gone. Ms. Jacob has decided not to repair these crumbling areas for fear that that would cause even more damage to the monument.

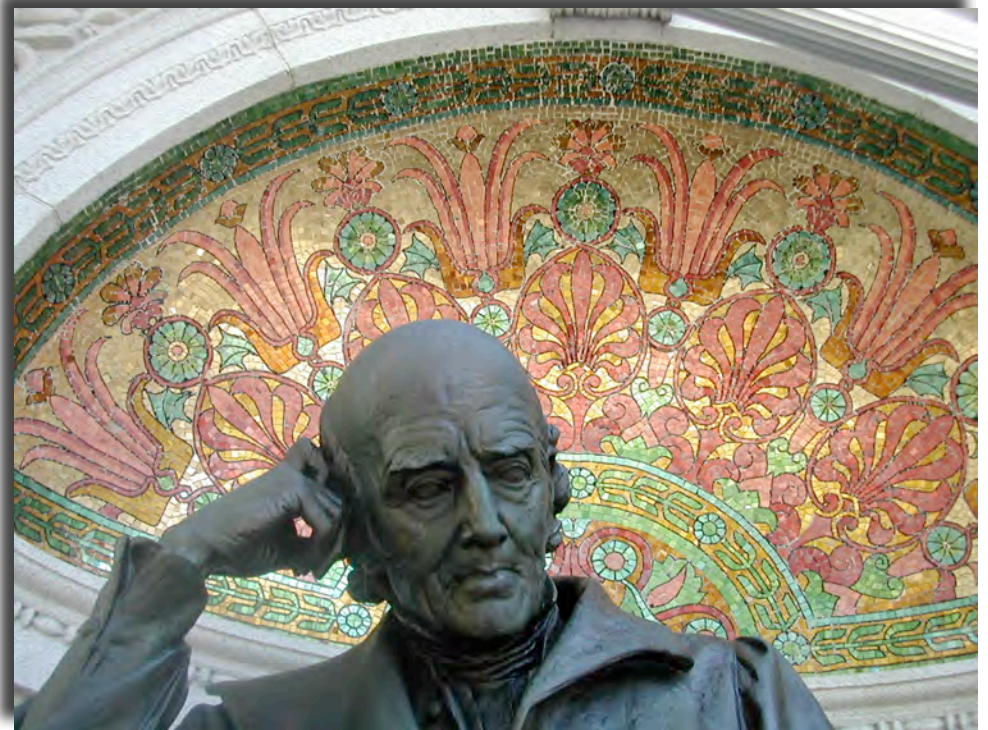
On Wednesday, 28 September 2005, I returned to the Hahnemann Monument when Ms. Jacob had come back to continue work on the renovation of the memorial. This time she had two other colleagues joining her on the project. The scaffolding was still there to allow restoration work to be carried out on the statue of Hahnemmann itself. Substantial portions of the statue had been cleaned and waxed. An area represented by his shoes and the drape of his robe to the right still shows the green color of the effects of the elements.

The mosaic arch repair had been completed the previous spring. The experts were turning their attention to other aspects of the renovation of the monument.

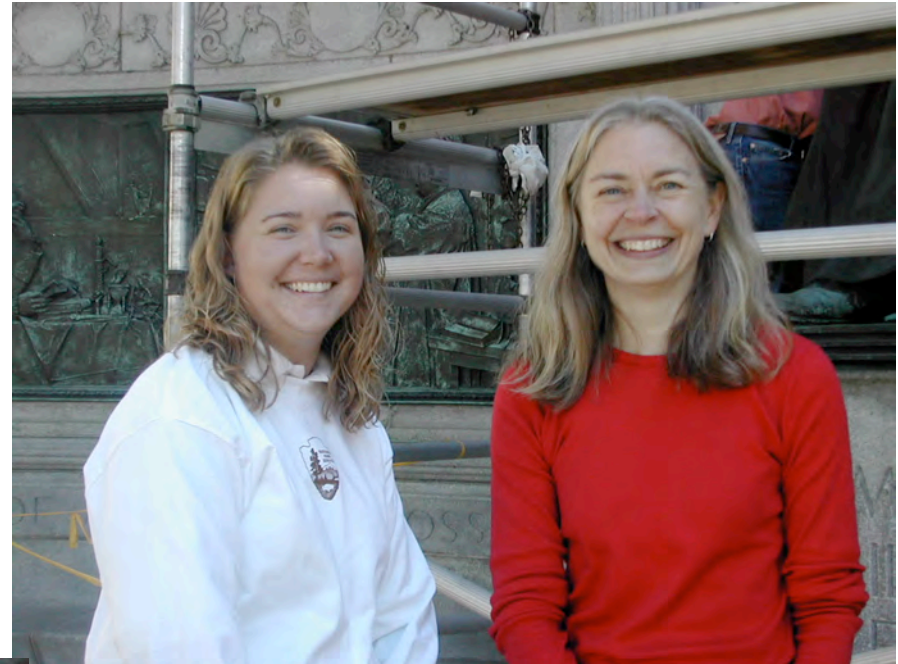
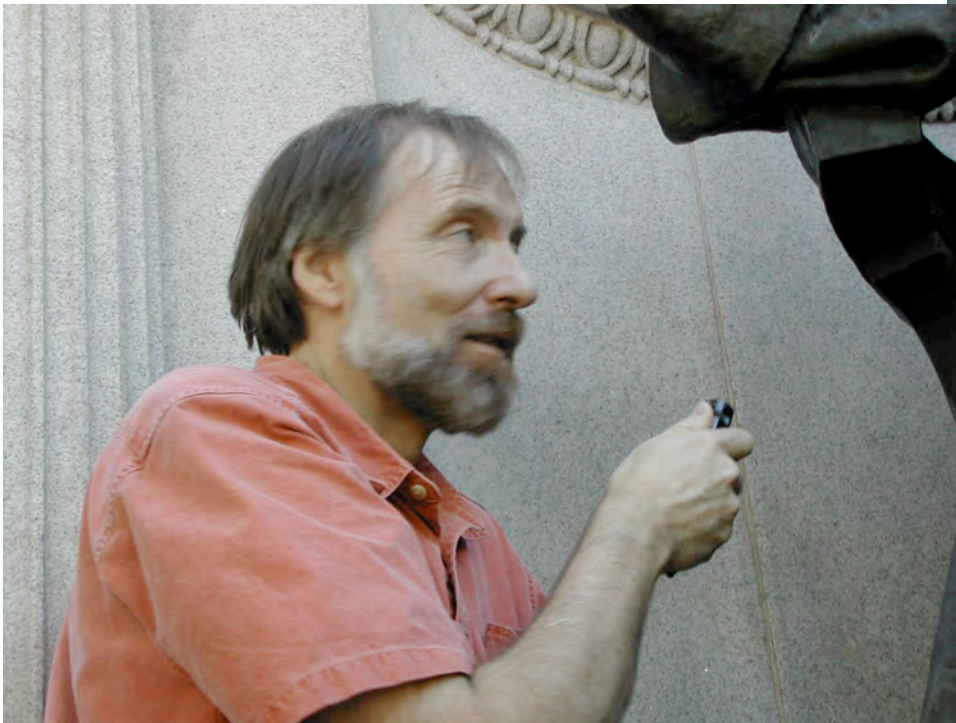
Consultant John Twilley, Art Conservation Scientist was there to take samples of the surface of the bronze from the rear of the statue. These samples hopefully would allow determination of the original patina of the statue.

That email also provided me with an update on the progress of the Hahnemann Monument Restoration Project. Ms. Jacob would be bringing a copy of the patina analysis of the bronze sculpture by Art Conservation Scientist John Twilley with her on her trip to Washington on 27 March 2006. While the analysis did not find evidence of the original patina, it does provide knowledge useful for decisions for any future work to repatinate the sculpture.

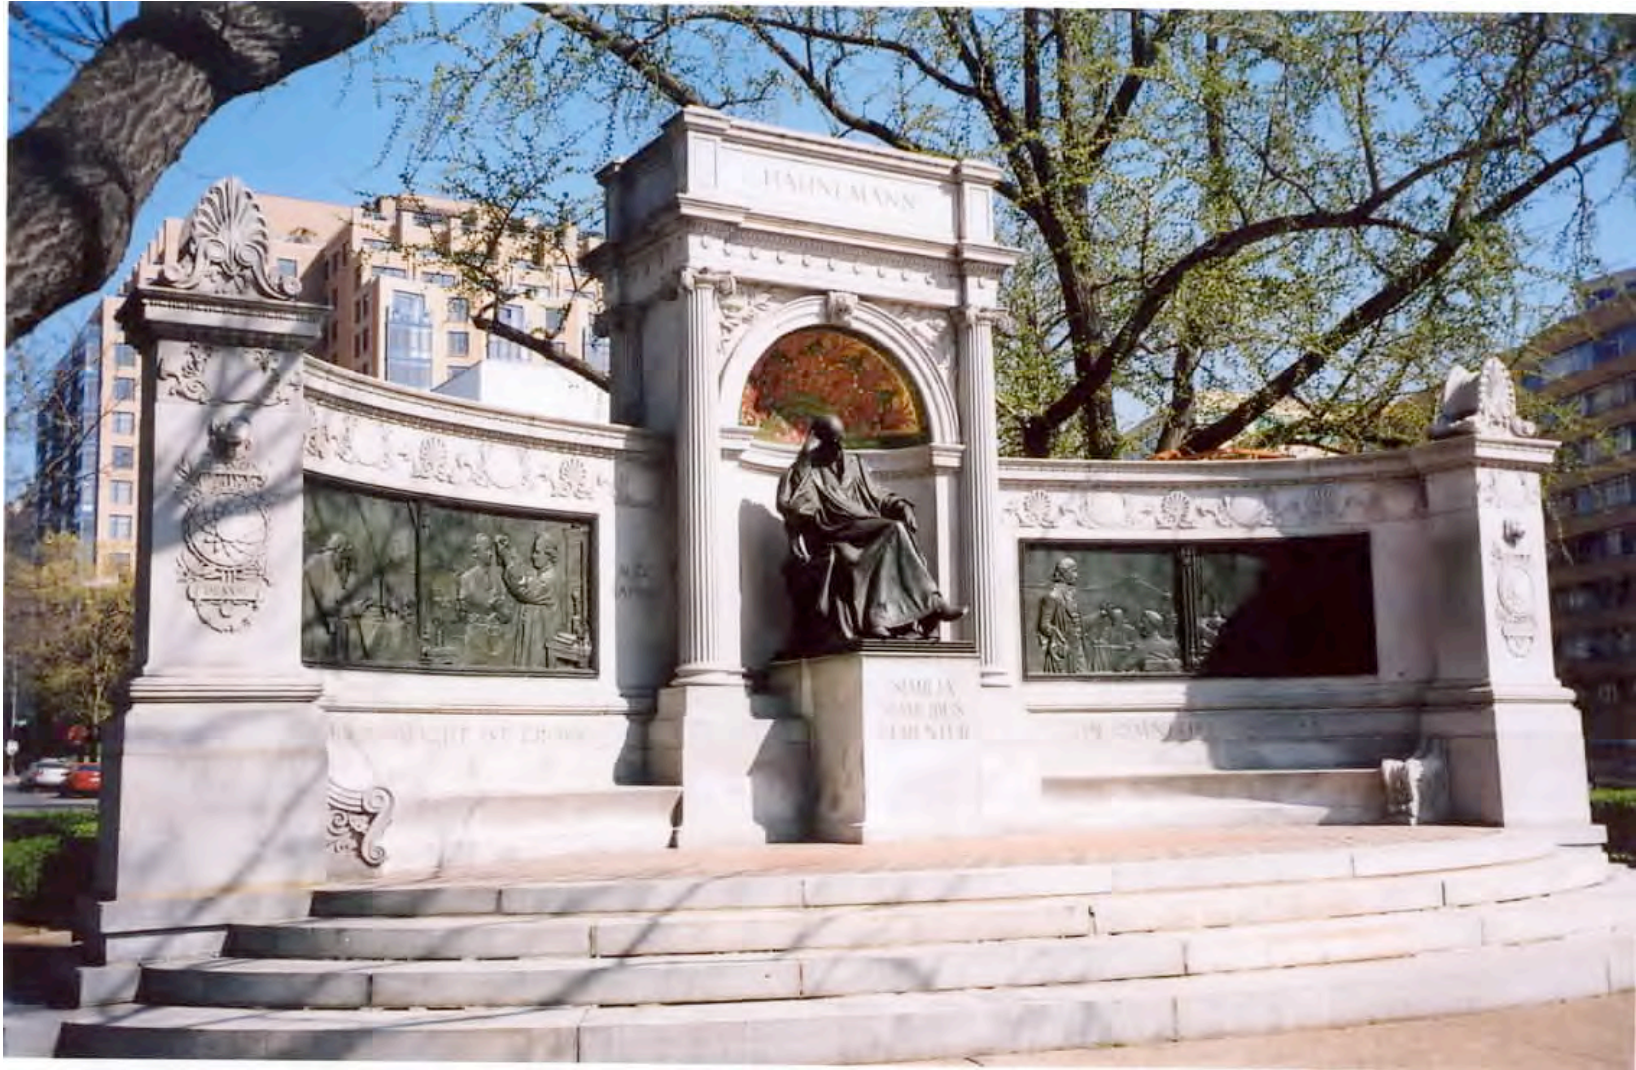
The lead joint T's had been installed at the top joints of the memorial. They provide a more permanent solution to the challenge of water intrusion and potential damage.

The mortar joints requiring repair were cut out last fall, but difficulties in acquiring the appropriate sand for the mortar delayed the completion of that part of the restoration until March of this year.

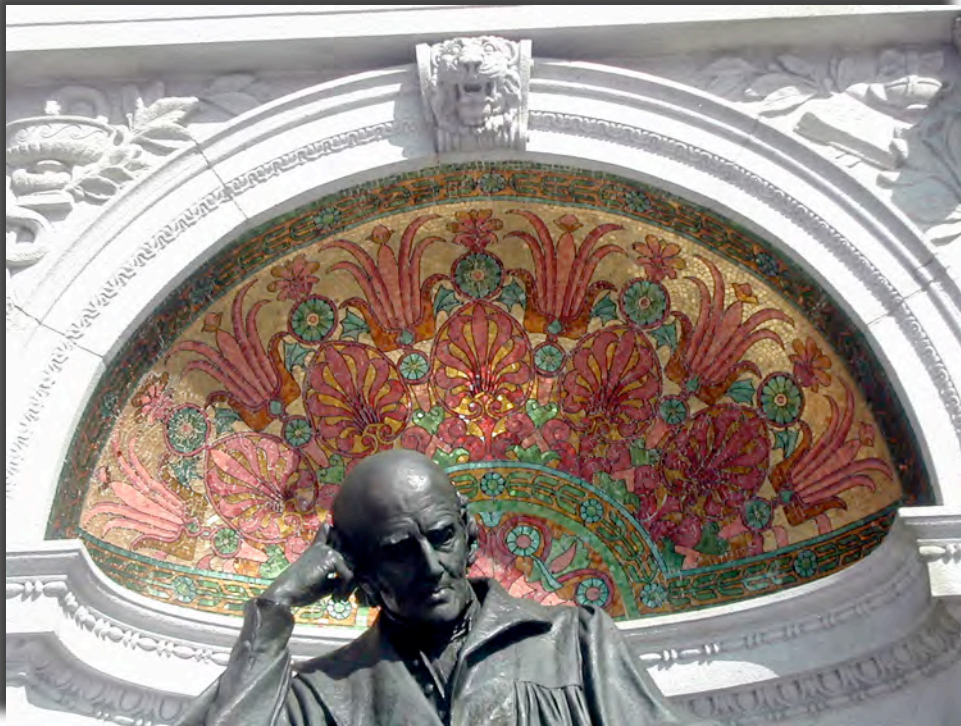
This artifice allows the mosaic arch to reflect the rays of the sun from the glass pieces and from the gold leaf exposed at the edges.

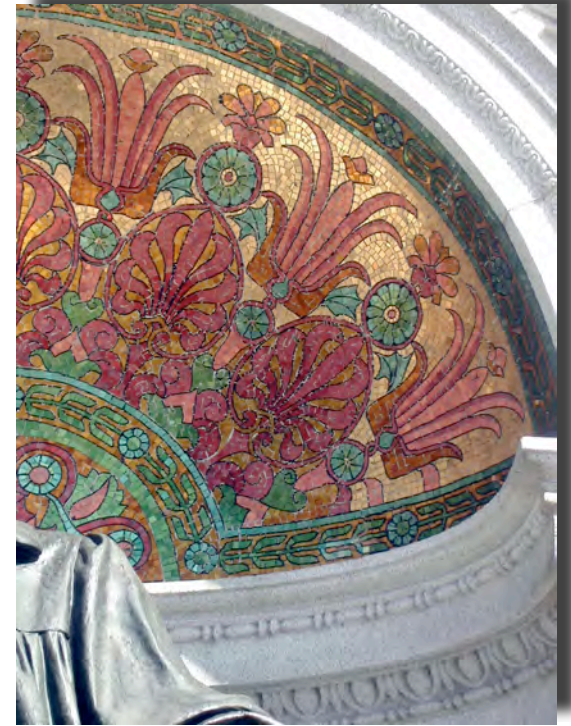
The pieces are not uniformly set in a plane and the grout deliberately does not come up to the upper surface of the glass.

At Judy Jacob's presentation at the NPS Conference at GMU Thursday 30 March 2006, I learned that the original tesserae were thick and have gold leaf between the layers of glass. With the sun in the west, the arch glows as if it were a stained glass window although solid granite sits behind it.

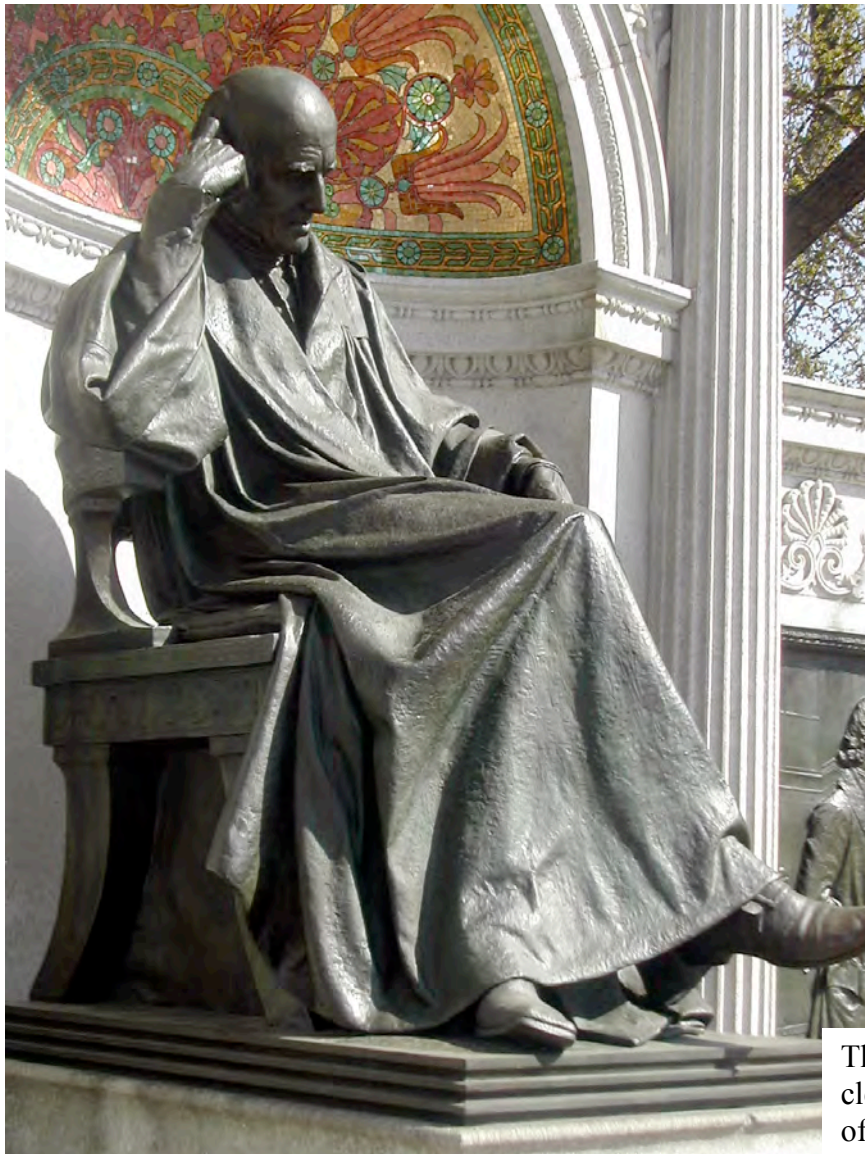
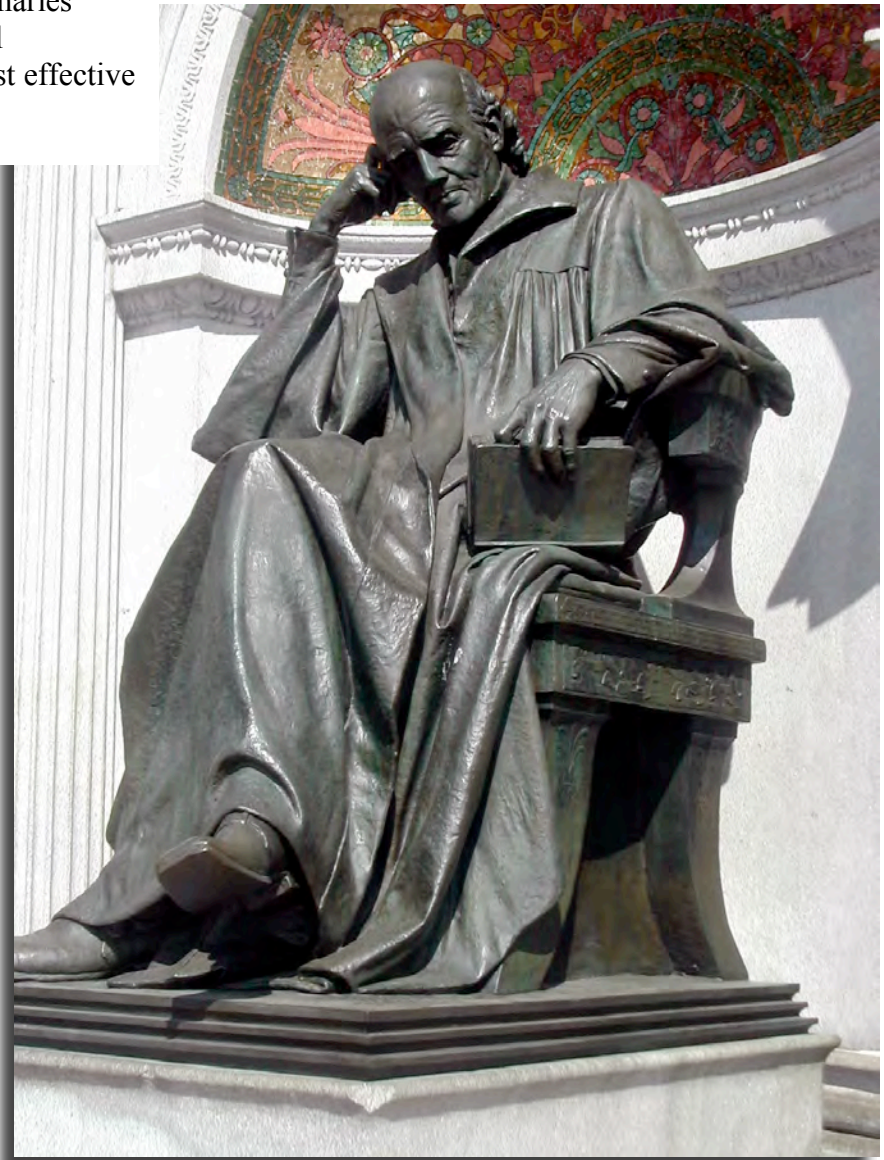
The bronze statue has been thoroughly cleaned and waxed as a part of the renovation of the memorial.

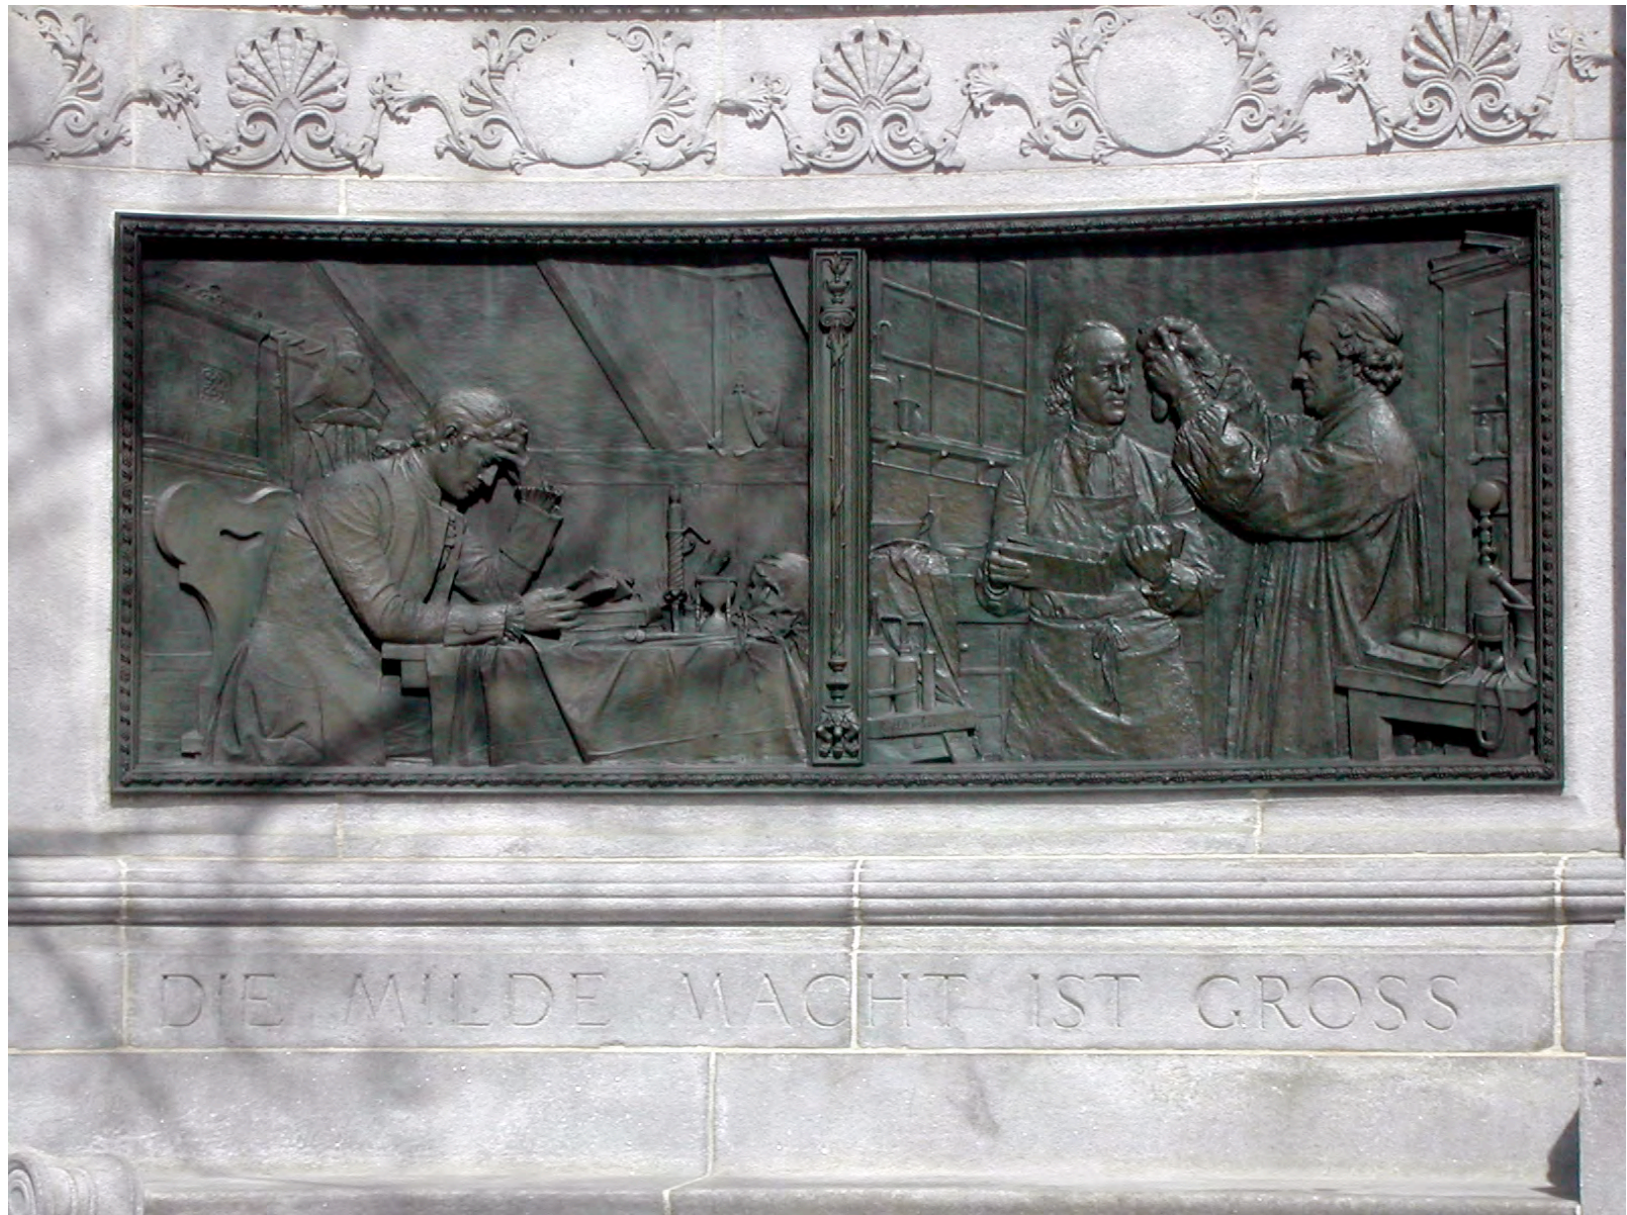
The bronze entablatures have been cleaned and waxed, as well.
This left entablature represents the nightly vigils of the student (1775-1777) and the investigations of the chemist (1779-1789)

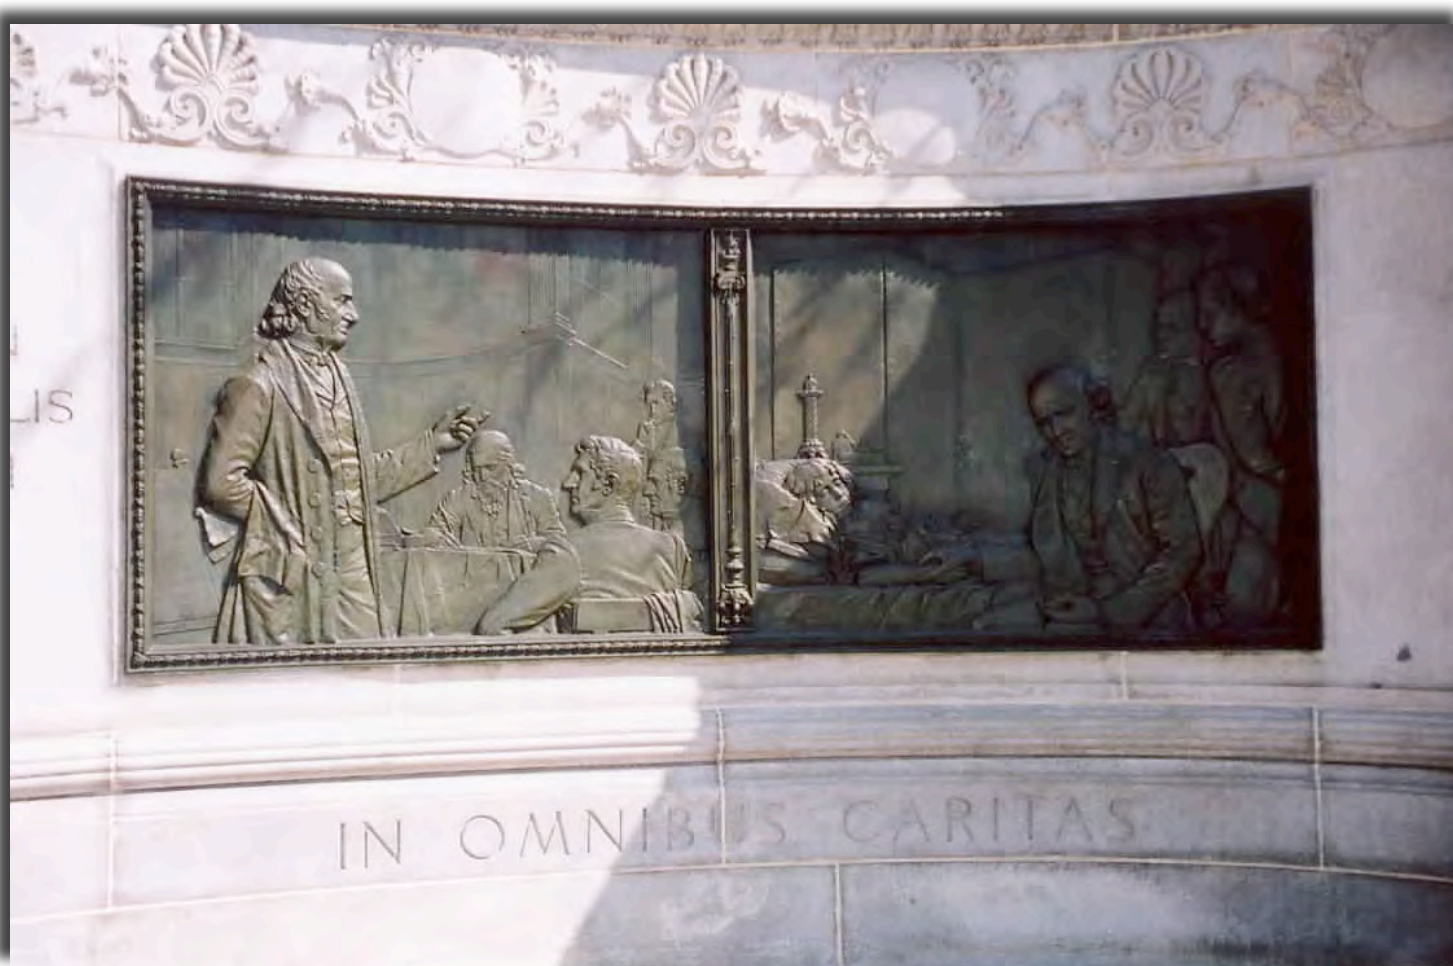
The right bronze entablature represents the self-experimentation and teaching (1790: *Cinchona*) and successful treatment of the typhus patients at Leipsic (1813).
